# AN INVESTIGATION INTO THE ENVIRONMENT DEGRATION OF THE SAND RIVER AND ITS IMPACT ON HUMAN RIGHTS IN THE CAPRICORN SOUTH DISTRICT.

**MOKGADI EMILY MASETHE**  
**GEOGRAPHY RESEARCH PROJECT**  
**GRADE 12**

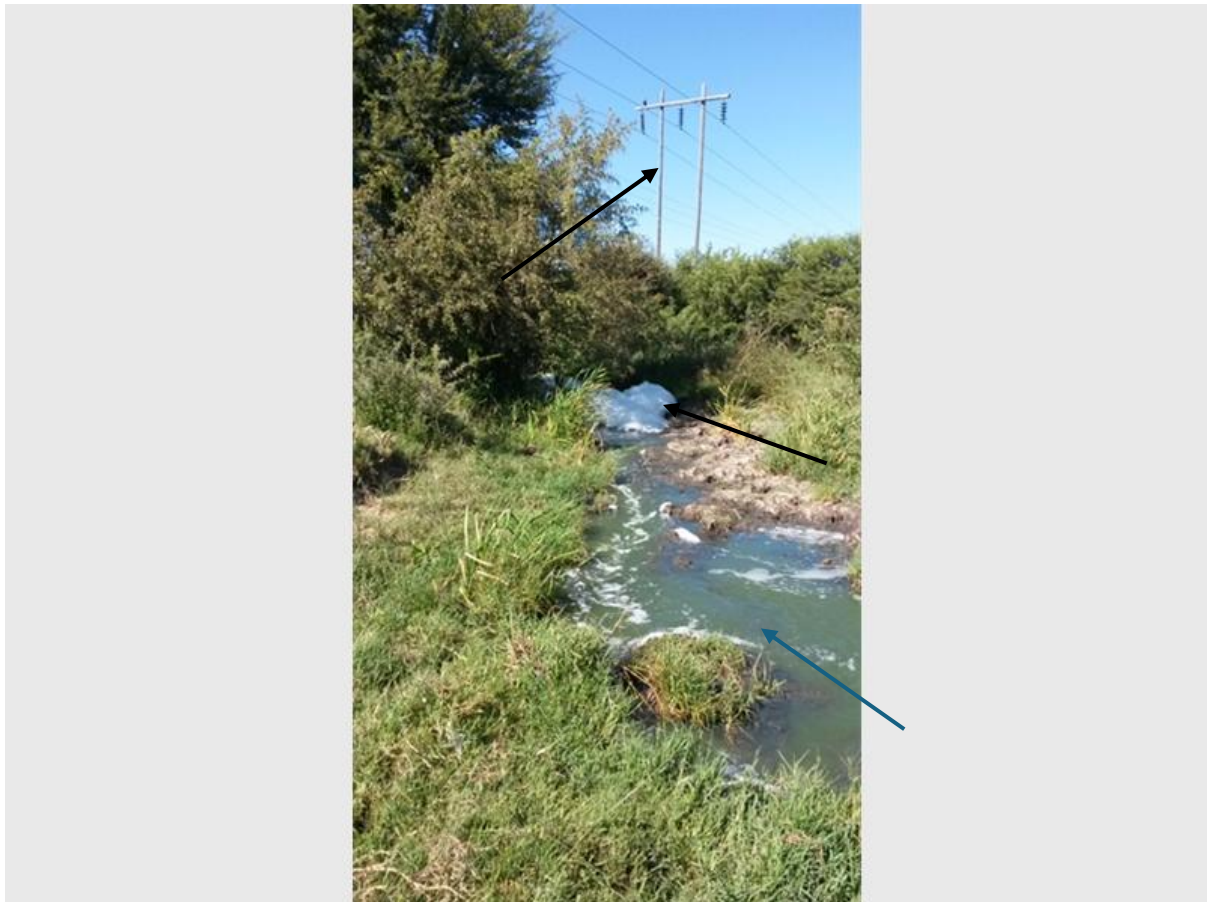
*Figure 3: Field photograph of the Sand River.*

The data from the community surveys and infrastructure reports is physically evident when visiting the study area. During my field observation, I recorded clear signs of environmental degradation that align with the high levels of reported illness and the sewage overflow statistics. The most critical evidence was the presence of industrial discharge points flowing directly into the Sand River without visible filtration.

1. **Chemical Foam:** The white, soapy foam visible in the background is a classic sign of industrial surfactants or detergents being dumped into the water. This directly supports the "industrial runoff" part of my hypothesis.
2. **Water Discoloration:** The water appears murky and grey green, indicating high turbidity and likely organic or chemical pollution (Eutrophication).
3. **Environmental Degradation:** We can see how the pollution is trapped by the reeds and vegetation, which proves the point about "damaging ecosystems."
4. **Proximity to Infrastructure:** The power lines in the background provide a sense of the "human-impacted landscape," showing that this is not a pristine natural area, but one affected by urban or industrial activity.

The primary solution to the degradation of the Sand River lies in the immediate expansion and modernization of the Polokwane Regional Wastewater Treatment Works. Based on the secondary data showing a 29-megalitre daily overflow, the municipality must implement a high-capacity filtration system capable of handling the current urban inflow of 65 ML/day. Additionally, the installation of "Catchment Traps" and industrial-grade filters at all major discharge points along the industrial zone is essential. These physical barriers will prevent non-biodegradable waste and heavy chemical surfactants (the white foam observed in the field study) from entering the river system, providing an immediate technical fix to the water quality crisis.

It is highly recommended that the Department of Water and Sanitation (DWS) enforces the "Polluter Pays" principle by conducting unannounced water quality audits on factories near the Sand River. Companies found to be exceeding legal discharge limits should be heavily fined, with those funds diverted into a "River Rehabilitation Fund" to restore the riparian ecosystem. Furthermore, a public health awareness campaign must be launched within the Capricorn South District to educate the 70% of residents experiencing health issues on the dangers of water-borne pathogens. Finally, the establishment of a "Green Buffer Zone"—planting indigenous vegetation along the banks—is recommended to act as a natural bio-filter for surface runoff before it reaches the water.
